## **TAMU Project**

**Energy Consumption Data Quality Assurance/Quality  
Control Assessment Report for the  
Month of March 2016**

**Utility & Energy Services  
Division of Administration  
Texas A&M University**

**April 2016**

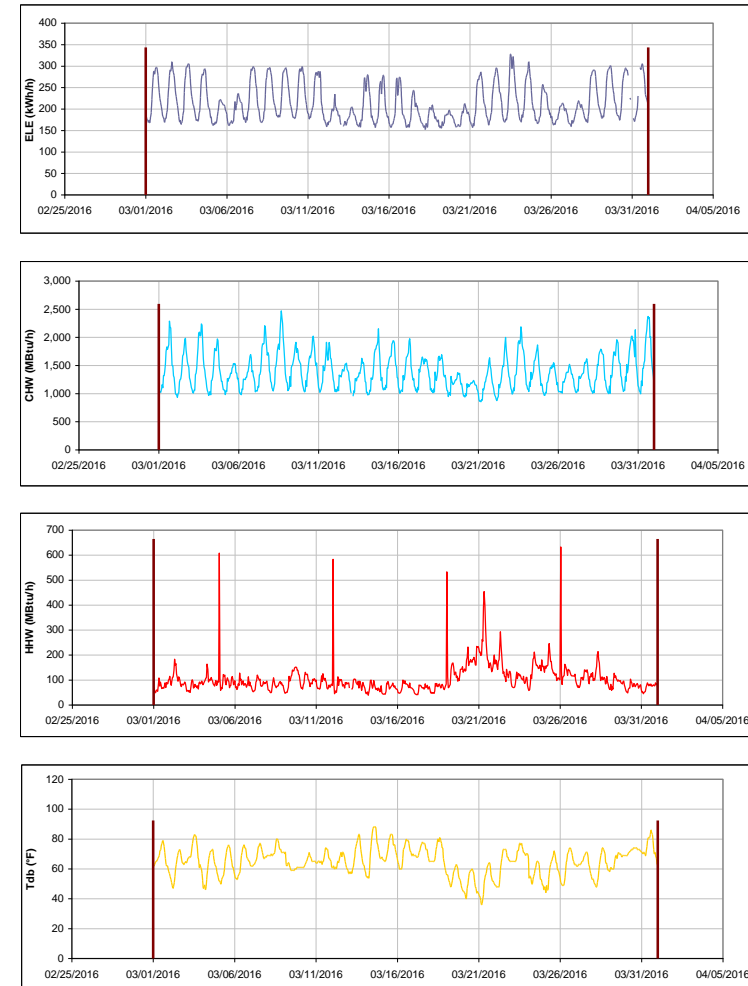
TAMU / BLDG #: 0353

Figure III-10 Hourly Whole Building Electricity, Chilled Water, and Hot Water Consumption for Bright Aerospace Building during the Month of March 2016 and the Corresponding Hourly Outdoor Dry Bulb Temperature for College Station, TX

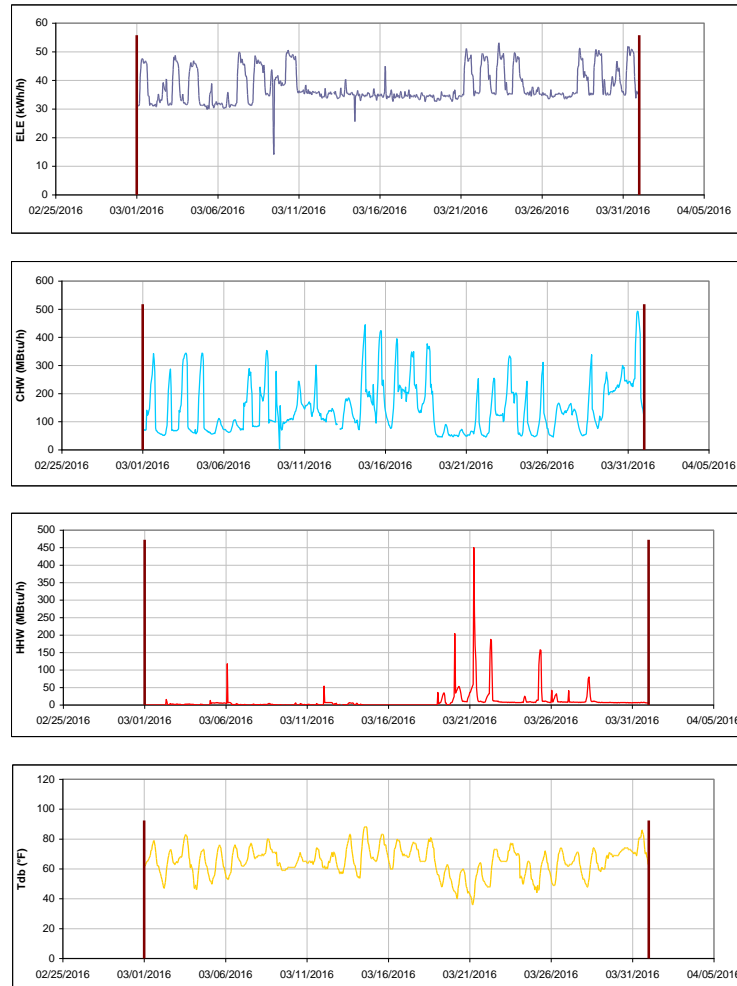
TAMU / BLDG #: 0358

Figure III-11 Hourly Whole Building Electricity, Chilled Water, and Hot Water Consumption for Davis Football Player Development Center during the Month of March 2016 and the Corresponding Hourly Outdoor Dry Bulb Temperature for College Station, TX

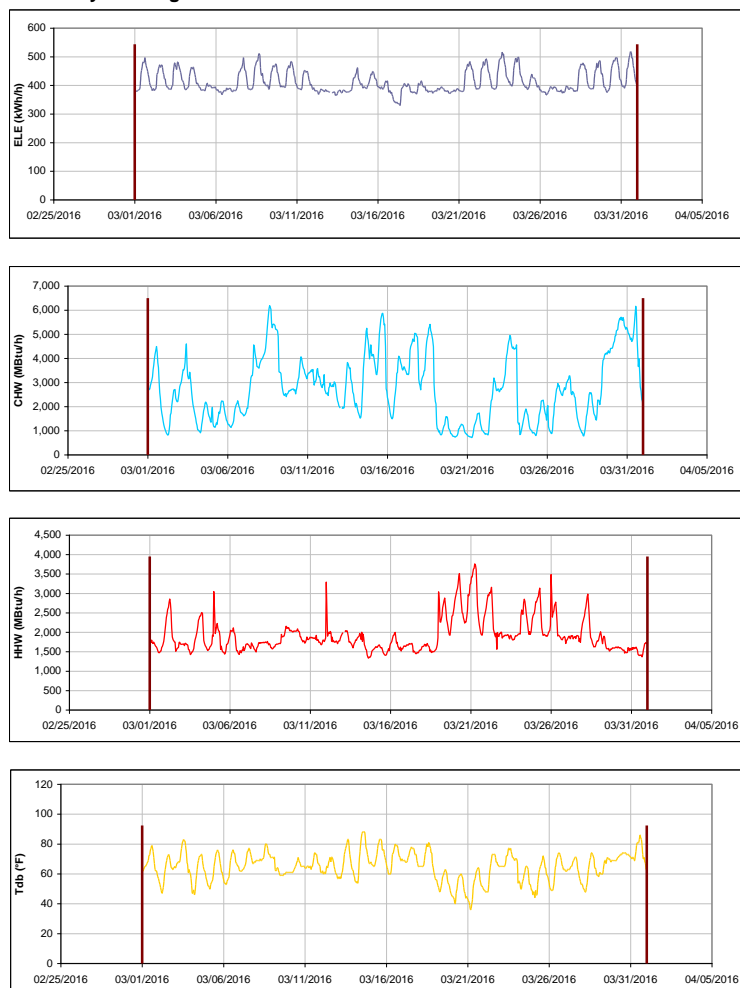
TAMU / BLDG #: 0376

Figure III-17 Hourly Whole Building Electricity, Chilled Water, and Hot Water Consumption for Chemistry Building Addition during the Month of March 2016 and the Corresponding Hourly Outdoor Dry Bulb Temperature for College Station, TX

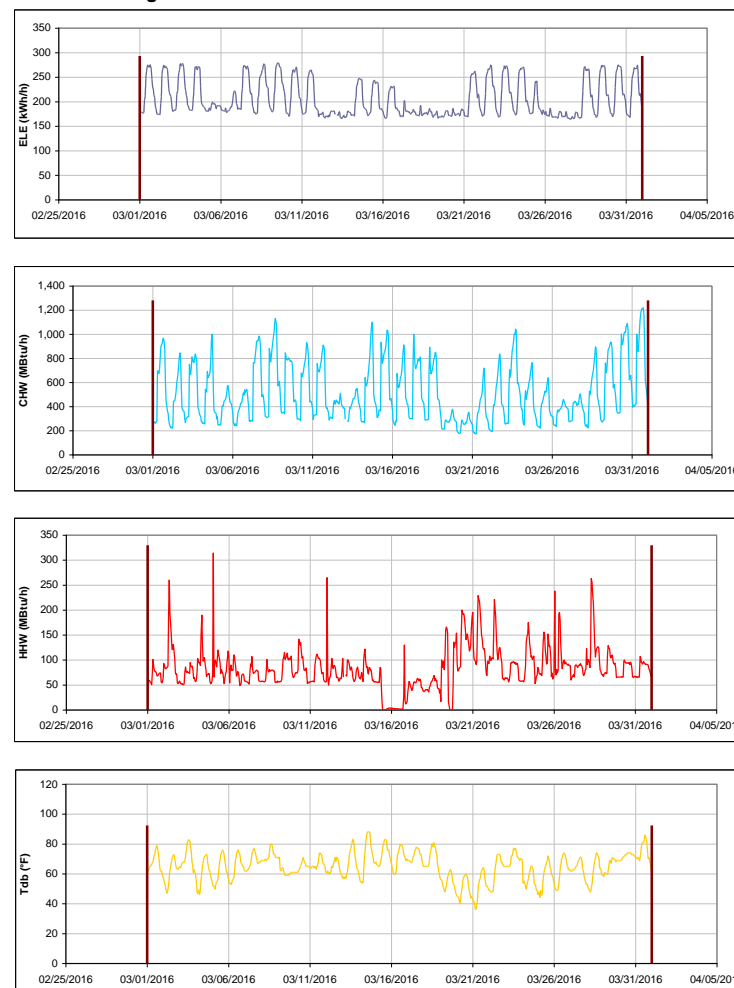
TAMU / BLDG #: 0383

Figure III-18 Hourly Whole Building Electricity, Chilled Water, and Hot Water Consumption for Koldus Building during the Month of March 2016 and the Corresponding Hourly Outdoor Dry Bulb Temperature for College Station, TX

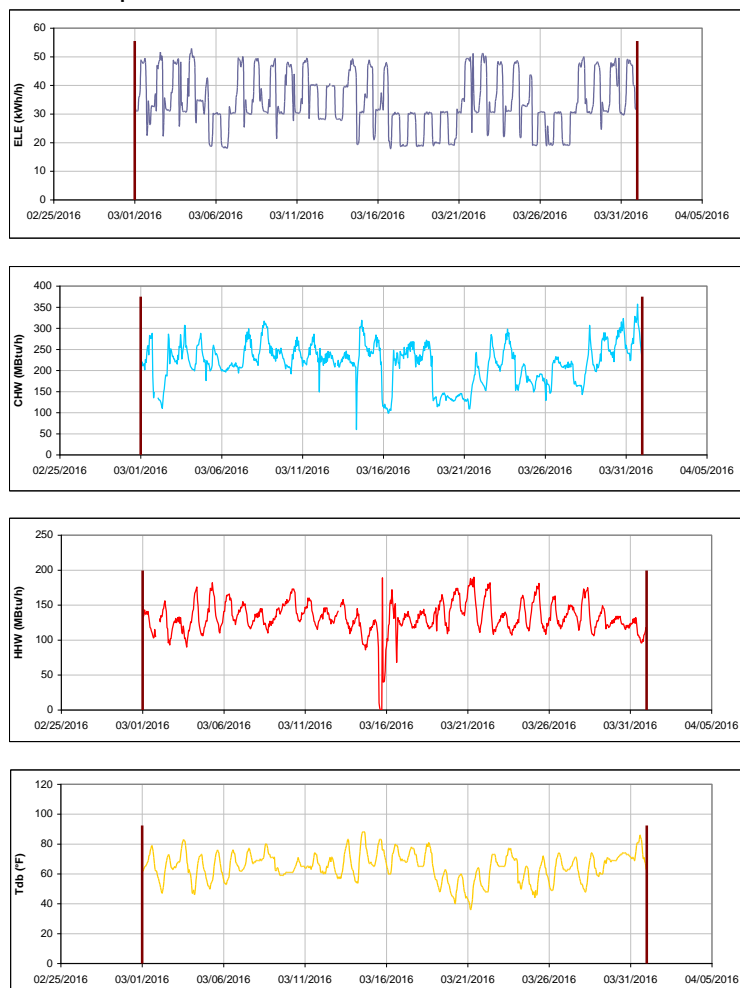
TAMU / BLDG #: 0384

Figure III-19 Hourly Whole Building Electricity, Chilled Water, and Hot Water Consumption for Sanders Corps of Cadets Center during the Month of March 2016 and the Corresponding Hourly Outdoor Dry Bulb Temperature for College Station, TX

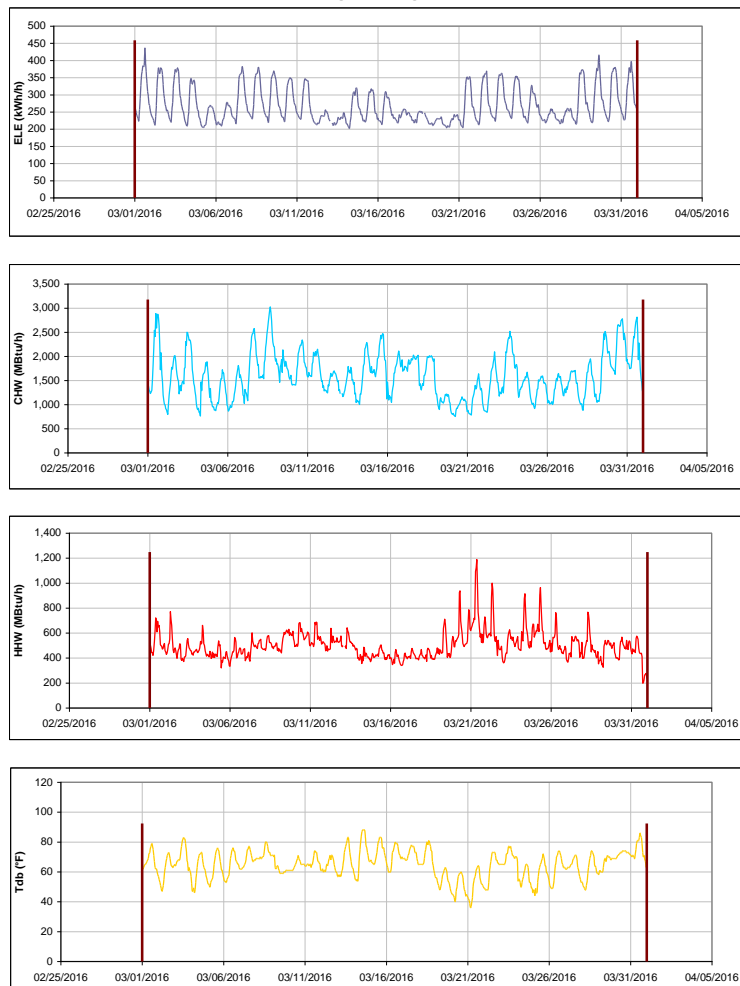
James J. Cain'51 and Mechanical Engineering Office Building / BLDG #: 3391-0392

Figure III-23 Hourly Whole Building Electricity, Chilled Water, and Hot Water Consumption for James J. Cain'51 and Mechanical Engineering Office Building during the Month of March 2016 and the Corresponding Hourly Outdoor Dry Bulb Temperature for College Station, TX

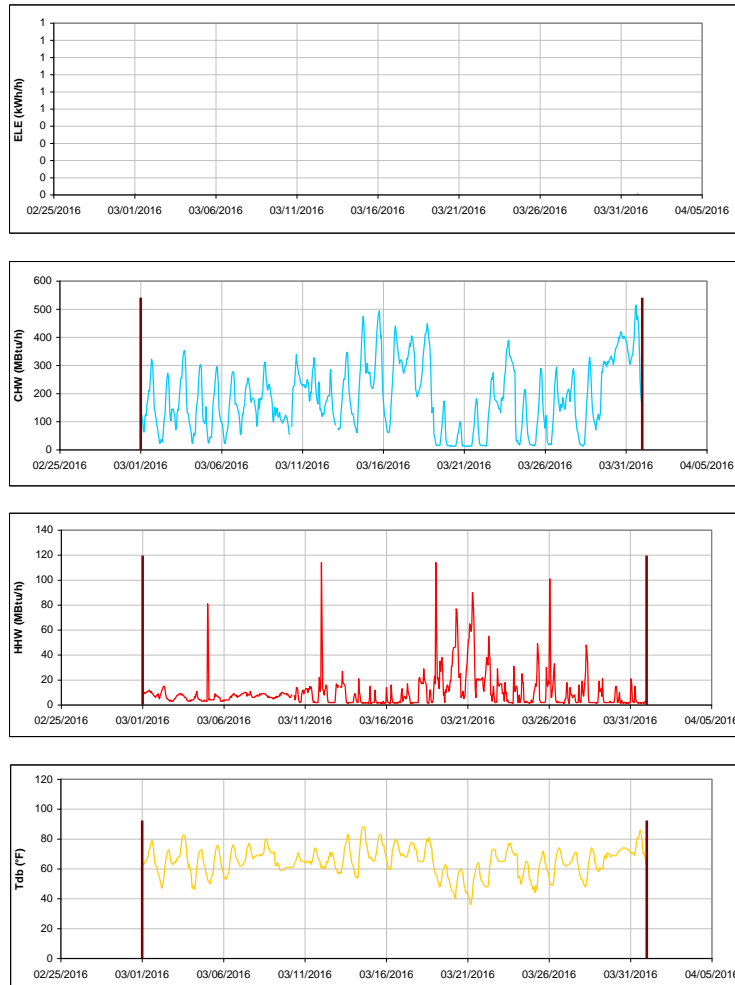
TAMU / BLDG #: 1402

Figure III-31 Hourly Whole Building Electricity, Chilled Water, and Hot Water Consumption for Buzbee Leadership Learning Center during the Month of March 2016 and the Corresponding Hourly Outdoor Dry Bulb Temperature for College Station, TX

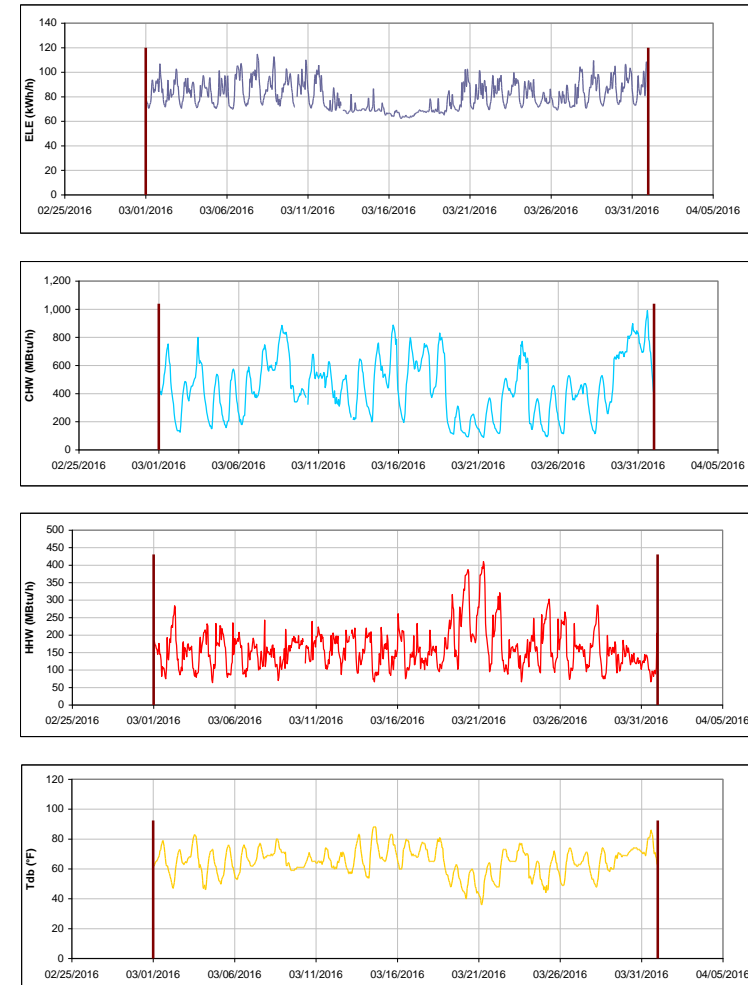
TAMU / BLDG #: J406-1403

Figure III-32 Hourly Whole Building Electricity, Chilled Water, and Hot Water Consumption for Leonard Hall - Dorm 7 and Ash LLC during the Month of March 2016 and the Corresponding Hourly Outdoor Dry Bulb Temperature for College Station, TX

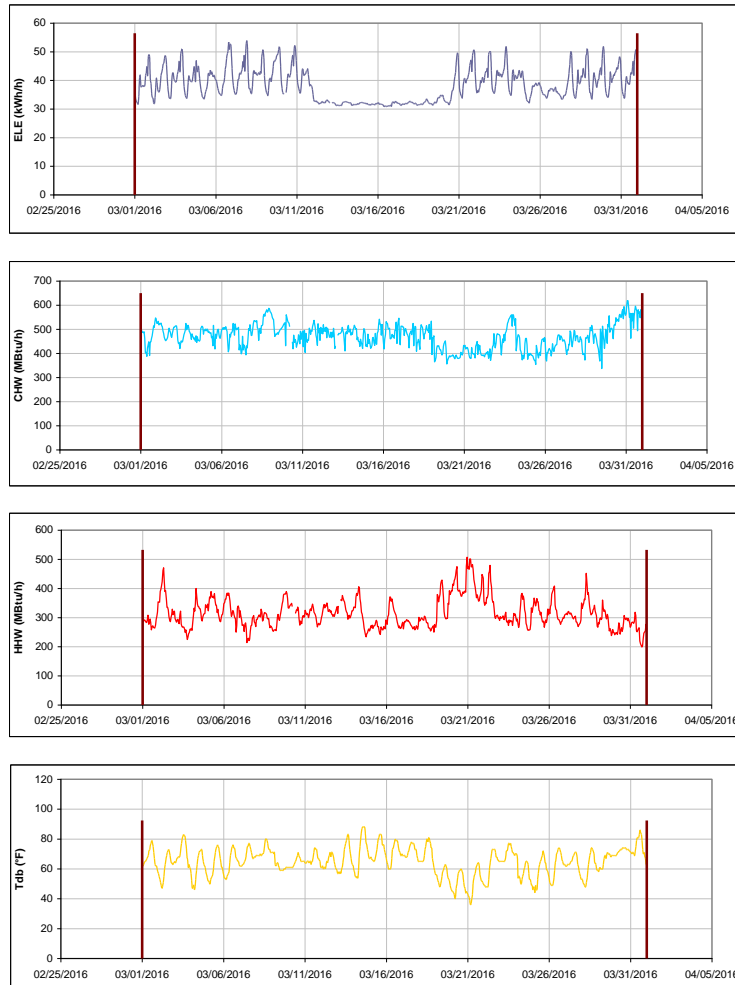
TAMU / BLDG #: 0408

Figure III-35 Hourly Whole Building Electricity, Chilled Water, and Hot Water Consumption for Whitely Hall - Dorm 9 during the Month of March 2016 and the Corresponding Hourly Outdoor Dry Bulb Temperature for College Station, TX

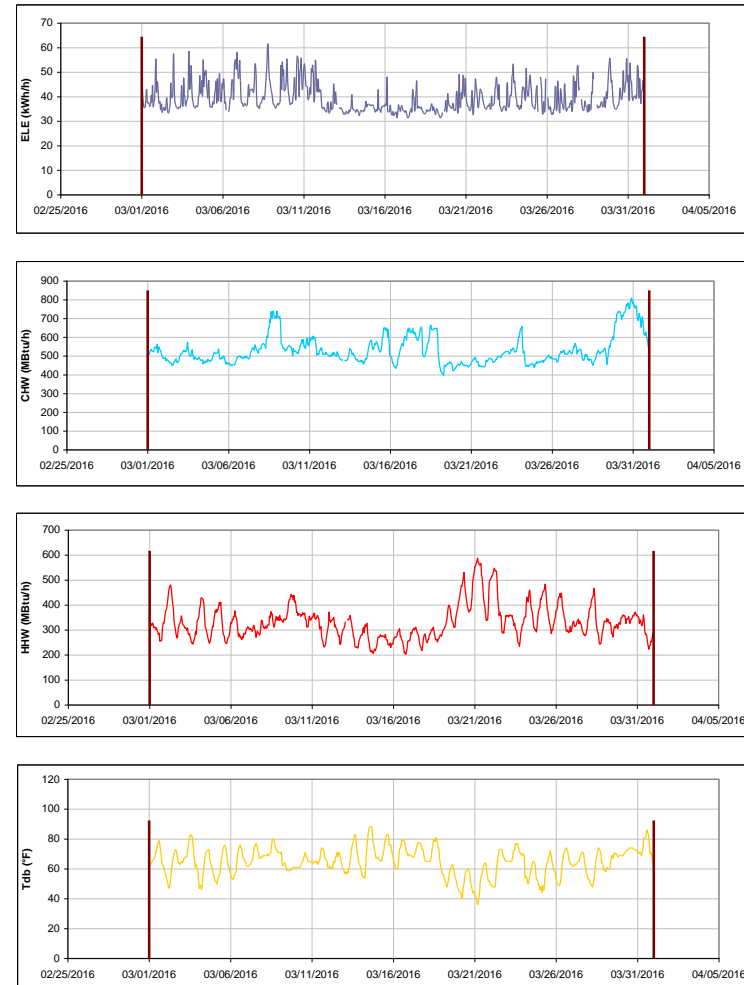
TAMU / BLDG #: 0415

Figure III-40 Hourly Whole Building Electricity, Chilled Water, and Hot Water Consumption for Davis-Gary Residence Hall during the Month of March 2016 and the Corresponding Hourly Outdoor Dry Bulb Temperature for College Station, TX

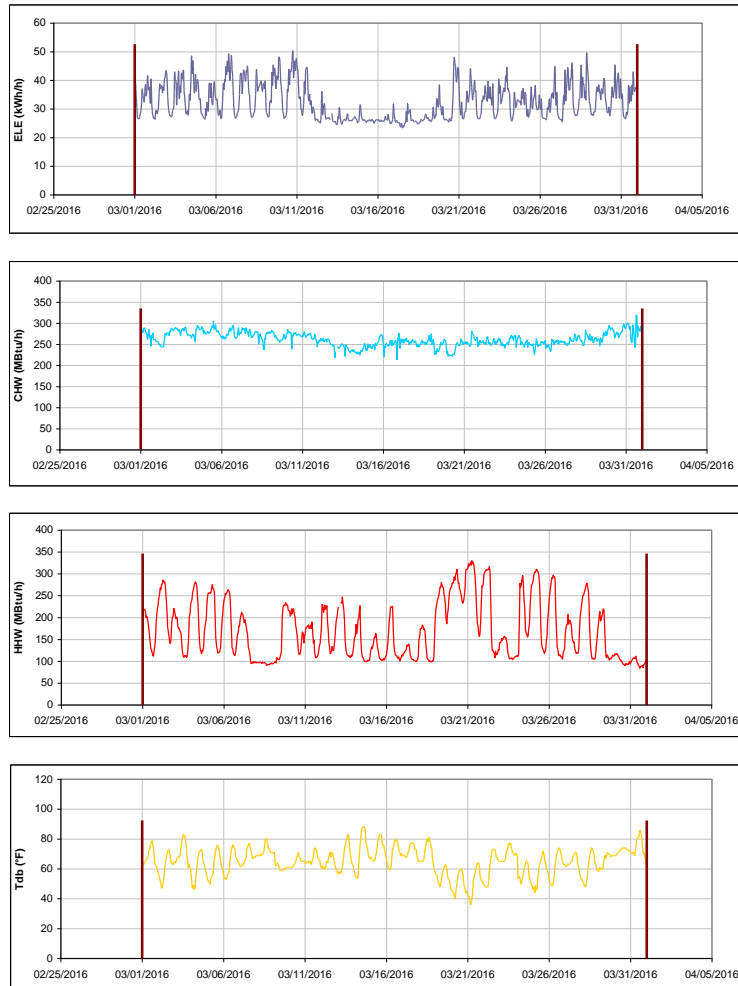
TAMU / BLDG #: 0419

Figure III-41 Hourly Whole Building Electricity, Chilled Water, and Hot Water Consumption for Legett Residence Hall during the Month of March 2016 and the Corresponding Hourly Outdoor Dry Bulb Temperature for College Station, TX

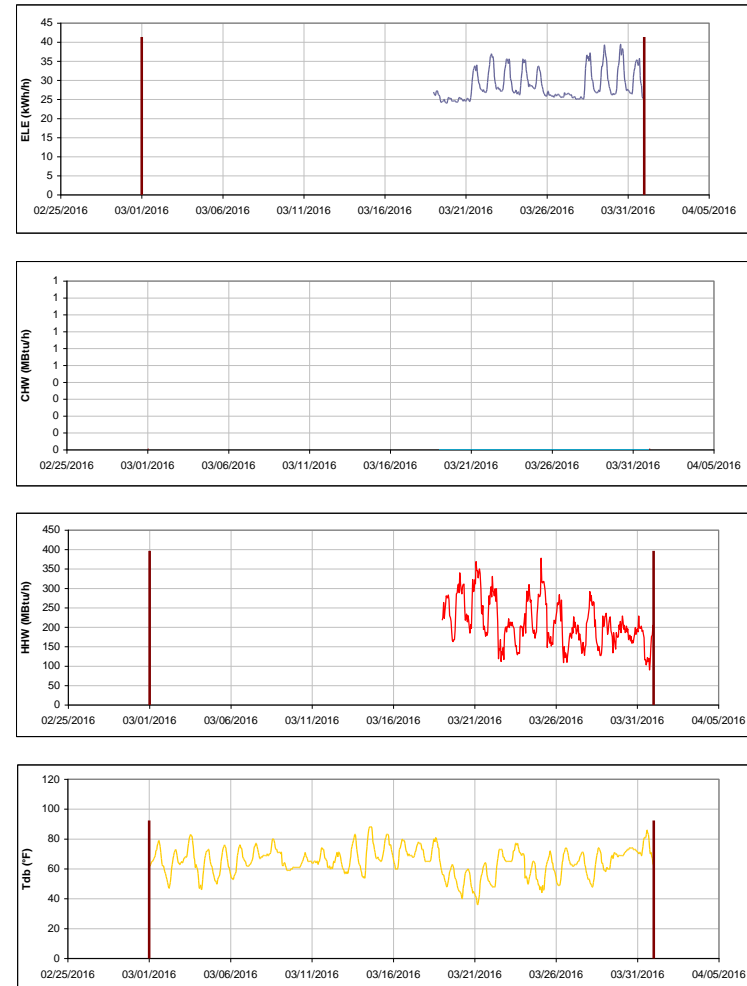
TAMU / BLDG #: 0420

Figure III-42 Hourly Whole Building Electricity, Chilled Water, and Hot Water Consumption for Milner Hall during the Month of March 2016 and the Corresponding Hourly Outdoor Dry Bulb Temperature for College Station, TX

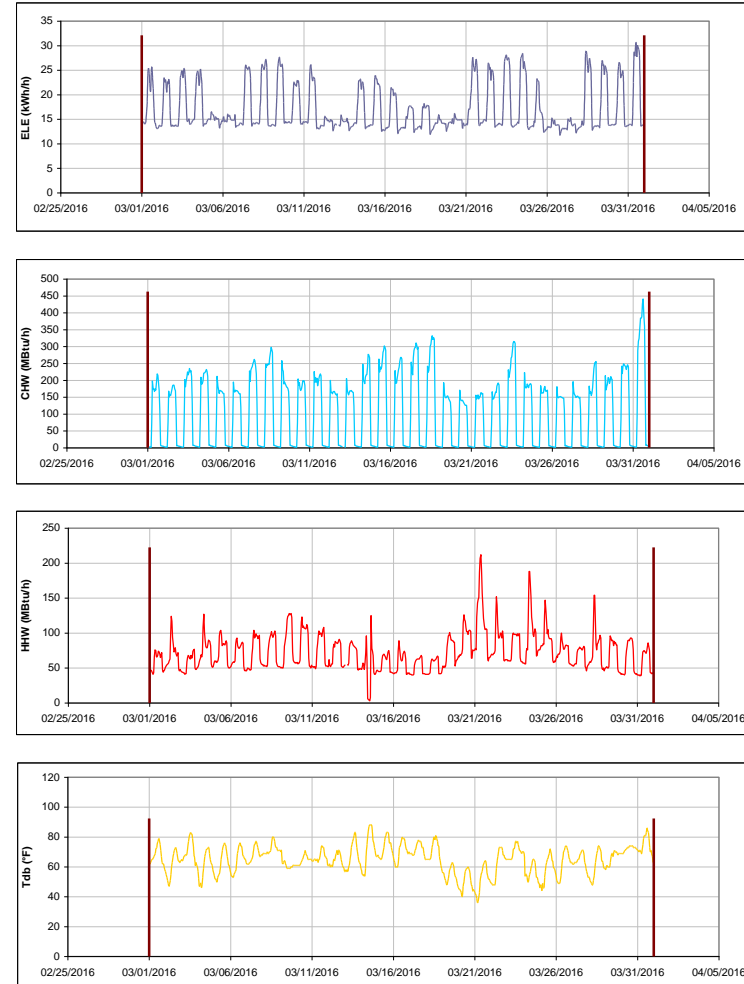
TAMU / BLDG #: 0424

Figure III-44 Hourly Whole Building Electricity, Chilled Water, and Hot Water Consumption for Hotard Hall during the Month of March 2016 and the Corresponding Hourly Outdoor Dry Bulb Temperature for College Station, TX

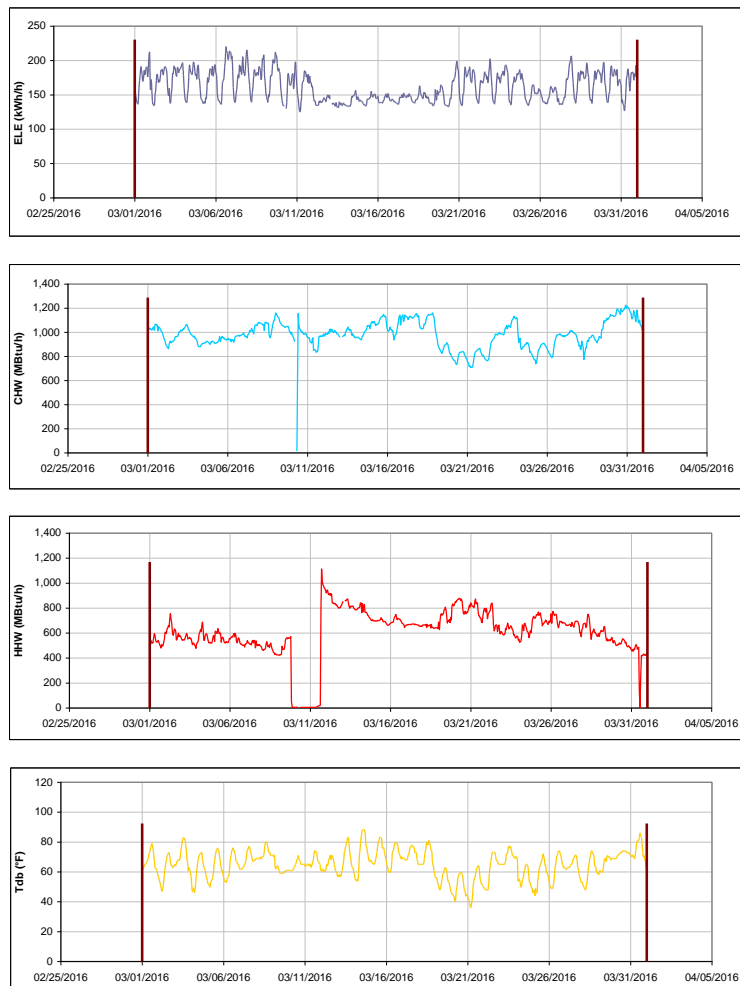
TAMU / BLDG #: 0442

Figure III-51 Hourly Whole Building Electricity, Chilled Water, and Hot Water Consumption for Dunn Residence Hall during the Month of March 2016 and the Corresponding Hourly Outdoor Dry Bulb Temperature for College Station, TX

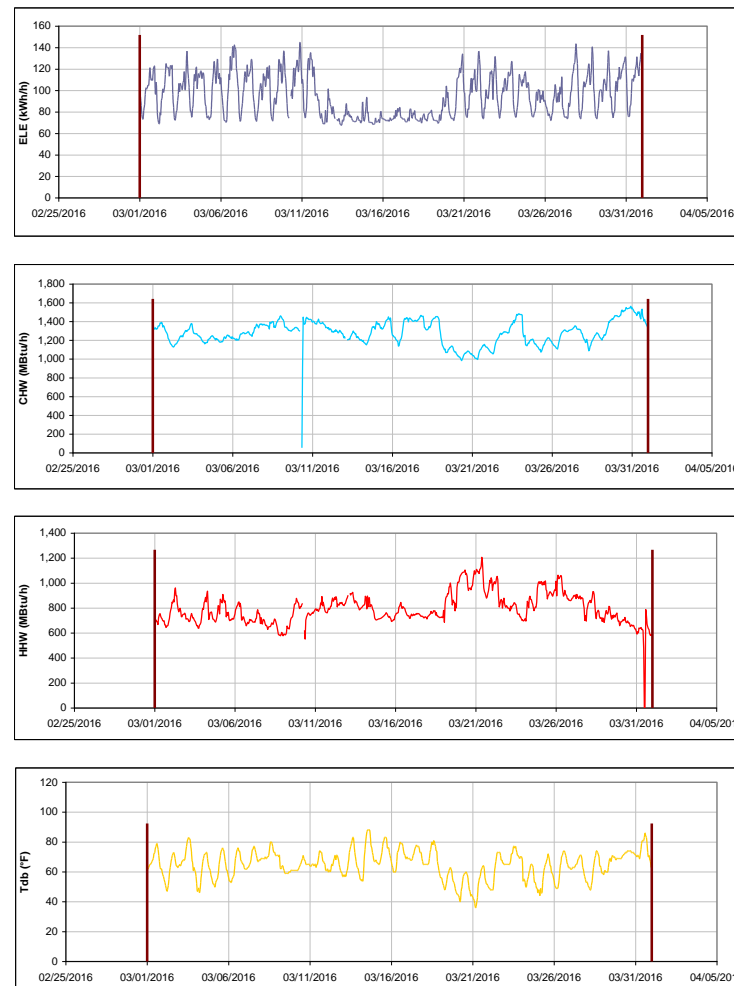
TAMU / BLDG #: 0447

Figure III-52 Hourly Whole Building Electricity, Chilled Water, and Hot Water Consumption for Aston Residence Hall during the Month of March 2016 and the Corresponding Hourly Outdoor Dry Bulb Temperature for College Station, TX

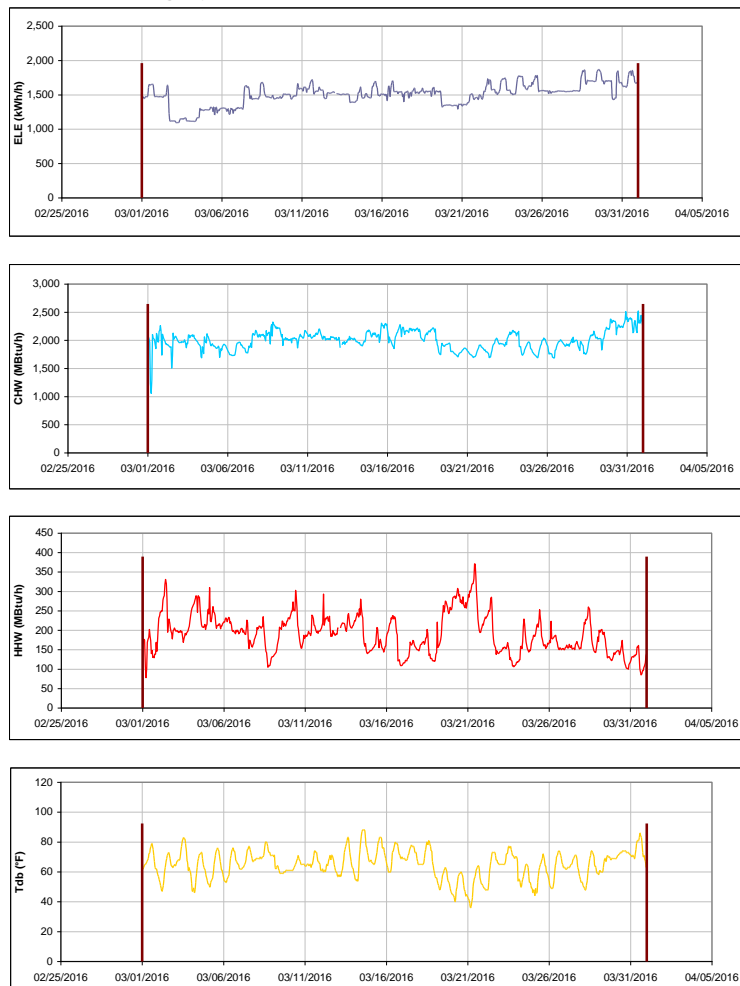
TAMU / BLDG #: 0434

Figure III-53 Hourly Whole Building Electricity, Chilled Water, and Hot Water Consumption for Luedecke Building (Cyclotron) during the Month of March 2016 and the Corresponding Hourly Outdoor Dry Bulb Temperature for College Station, TX

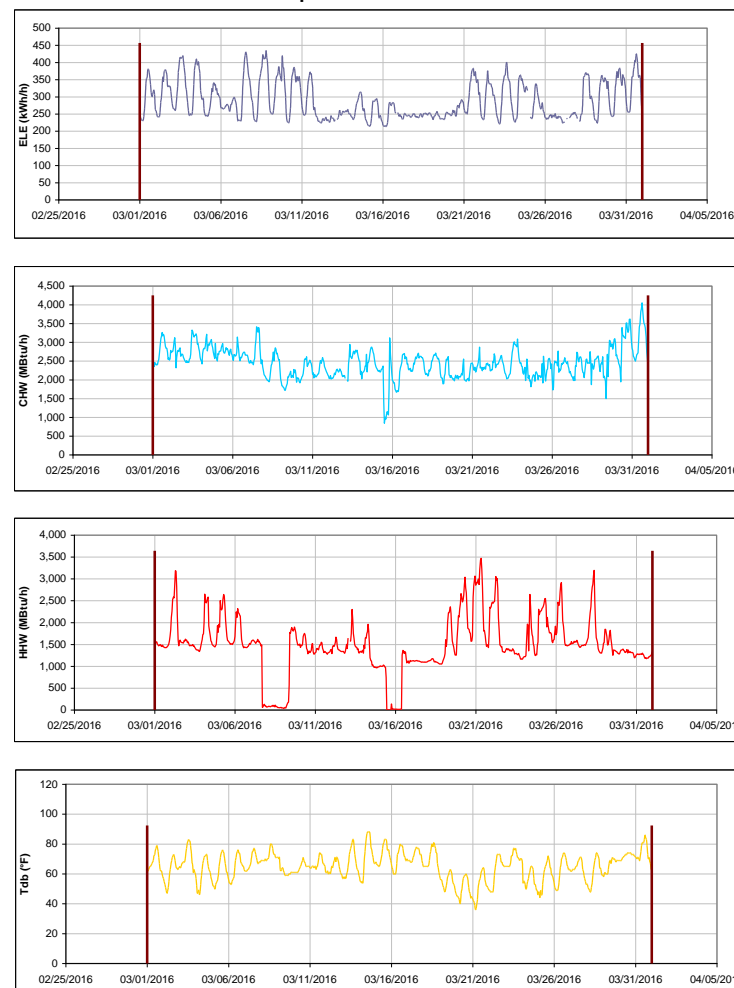
TAMU / BLDG #: 0446

Figure III-64 Hourly Whole Building Electricity, Chilled Water, and Hot Water Consumption for Rudder Tower and Theatre Complex during the Month of March 2016 and the Corresponding Hourly Outdoor Dry Bulb Temperature for College Station, TX

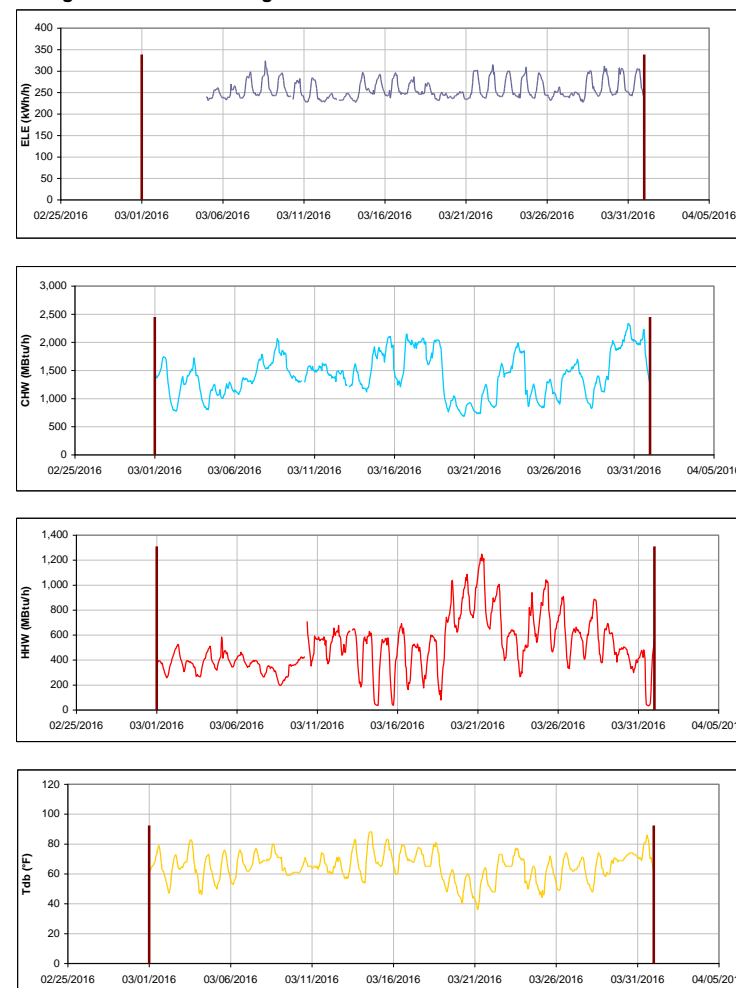
TAMU / BLDG #: 0449

Figure III-68 Hourly Whole Building Electricity, Chilled Water, and Hot Water Consumption for Biological Sciences Building - West during the Month of March 2016 and the Corresponding Hourly Outdoor Dry Bulb Temperature for College Station, TX

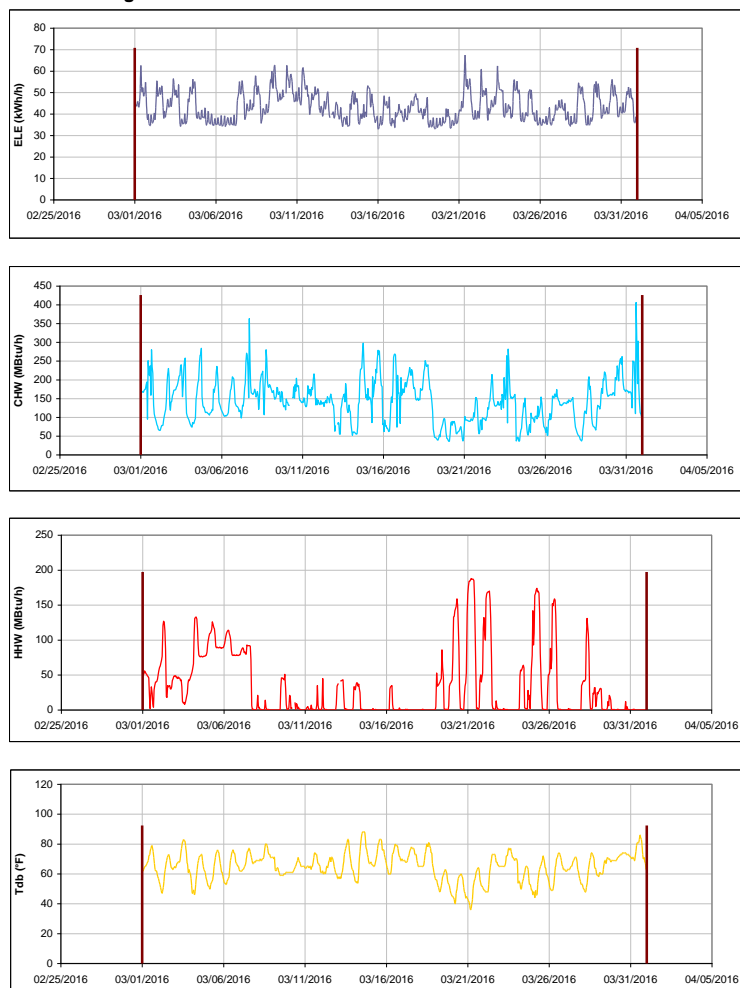
TAMU / BLDG #: 0461

Figure III-73 Hourly Whole Building Electricity, Chilled Water, and Hot Water Consumption for Coke Building during the Month of March 2016 and the Corresponding Hourly Outdoor Dry Bulb Temperature for College Station, TX

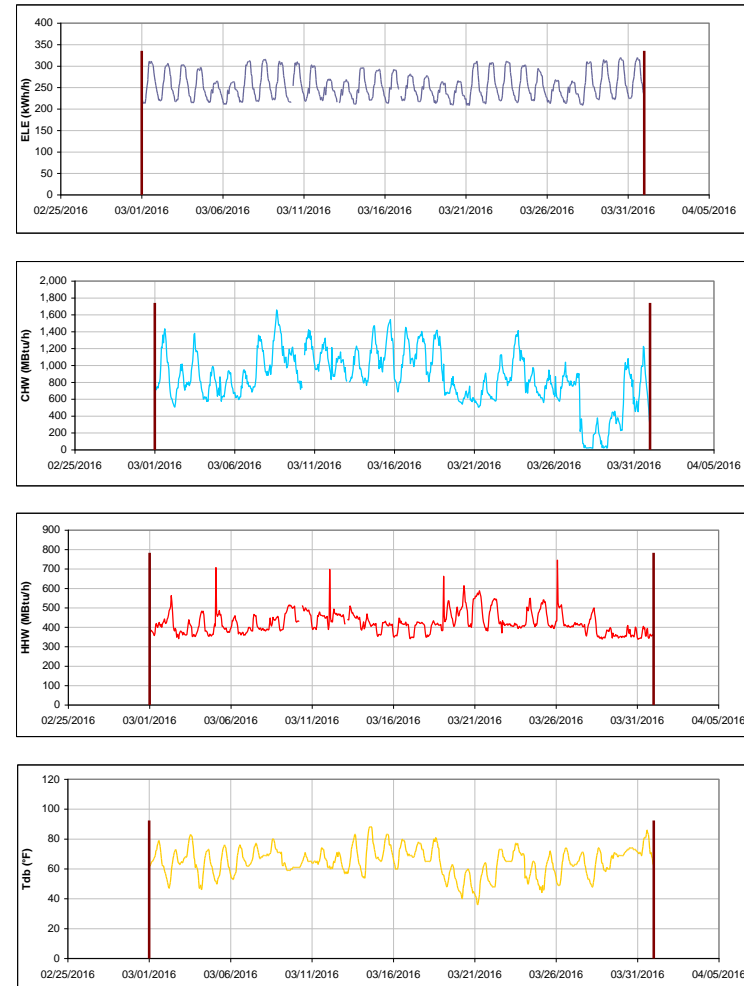
TAMU / BLDG #: 0467

Figure III-78 Hourly Whole Building Electricity, Chilled Water, and Hot Water Consumption for Biological Sciences Building - East during the Month of March 2016 and the Corresponding Hourly Outdoor Dry Bulb Temperature for College Station, TX

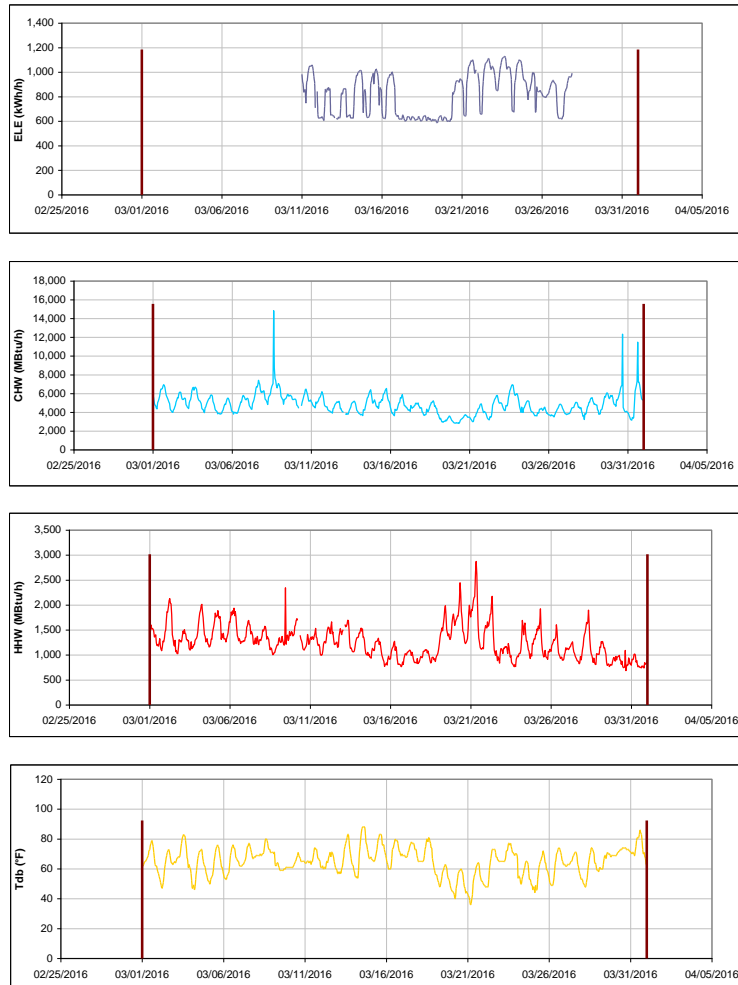
TAMU / BLDG #: 0468

Figure III-79 Hourly Whole Building Electricity, Chilled Water, and Hot Water Consumption for Evans Library during the Month of March 2016 and the Corresponding Hourly Outdoor Dry Bulb Temperature for College Station, TX

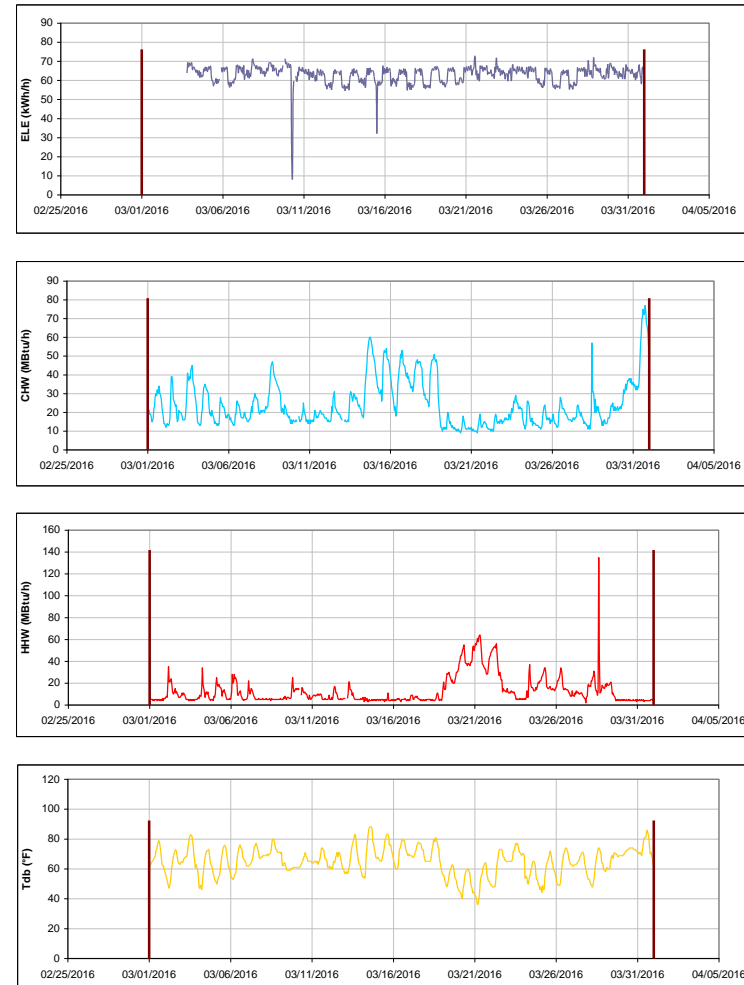
TAMU / BLDG #: 0469

Figure III-80 Hourly Whole Building Electricity, Chilled Water, and Hot Water Consumption for Central Campus Parking Garage during the Month of March 2016 and the Corresponding Hourly Outdoor Dry Bulb Temperature for College Station, TX

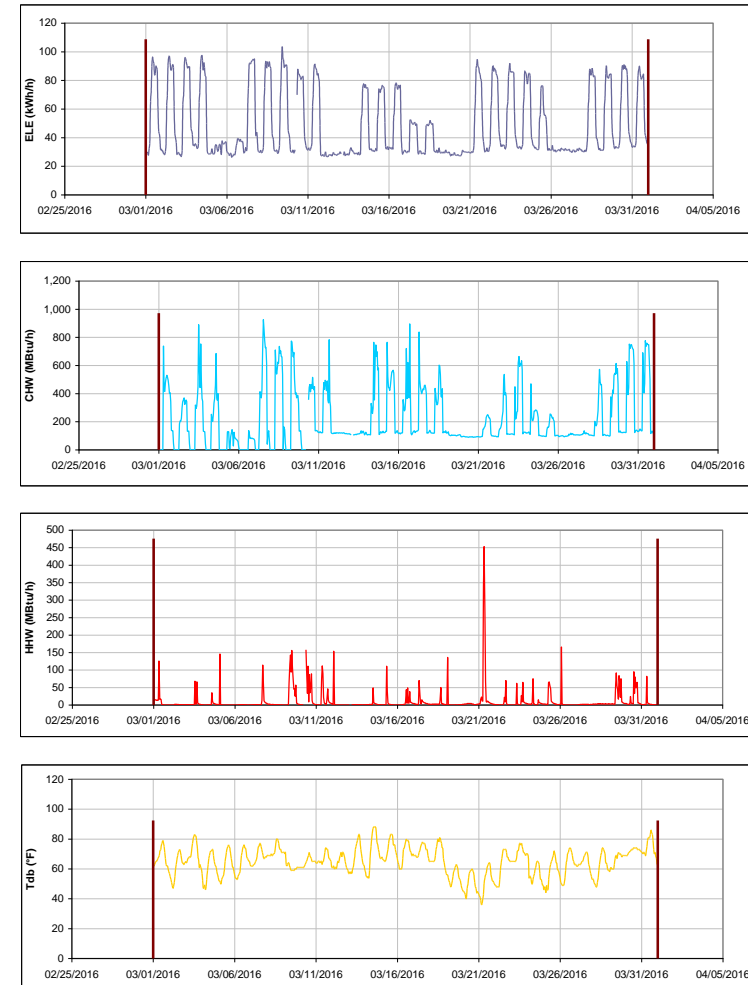
TAMU / BLDG #: 0471

Figure III-82 Hourly Whole Building Electricity, Chilled Water, and Hot Water Consumption for Pavilion during the Month of March 2016 and the Corresponding Hourly Outdoor Dry Bulb Temperature for College Station, TX

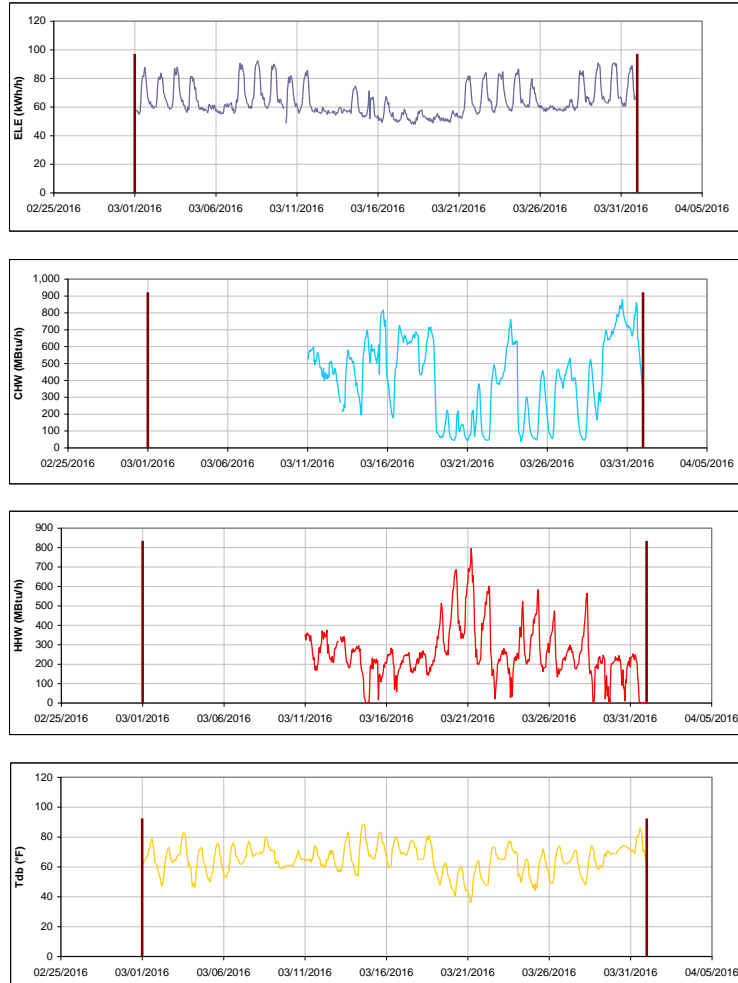
TAMU / BLDG #: 0472

Figure III-83 Hourly Whole Building Electricity, Chilled Water, and Hot Water Consumption for Animal Industries during the Month of March 2016 and the Corresponding Hourly Outdoor Dry Bulb Temperature for College Station, TX

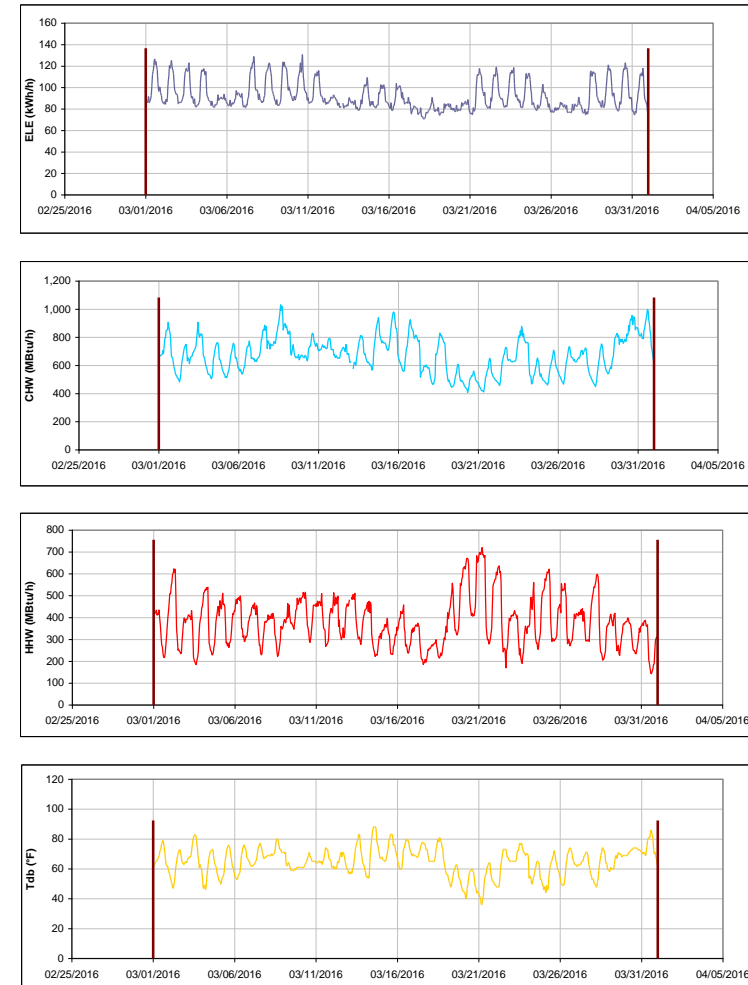
TAMU / BLDG #: 0478

Figure III-88 Hourly Whole Building Electricity, Chilled Water, and Hot Water Consumption for Scoates Hall during the Month of March 2016 and the Corresponding Hourly Outdoor Dry Bulb Temperature for College Station, TX

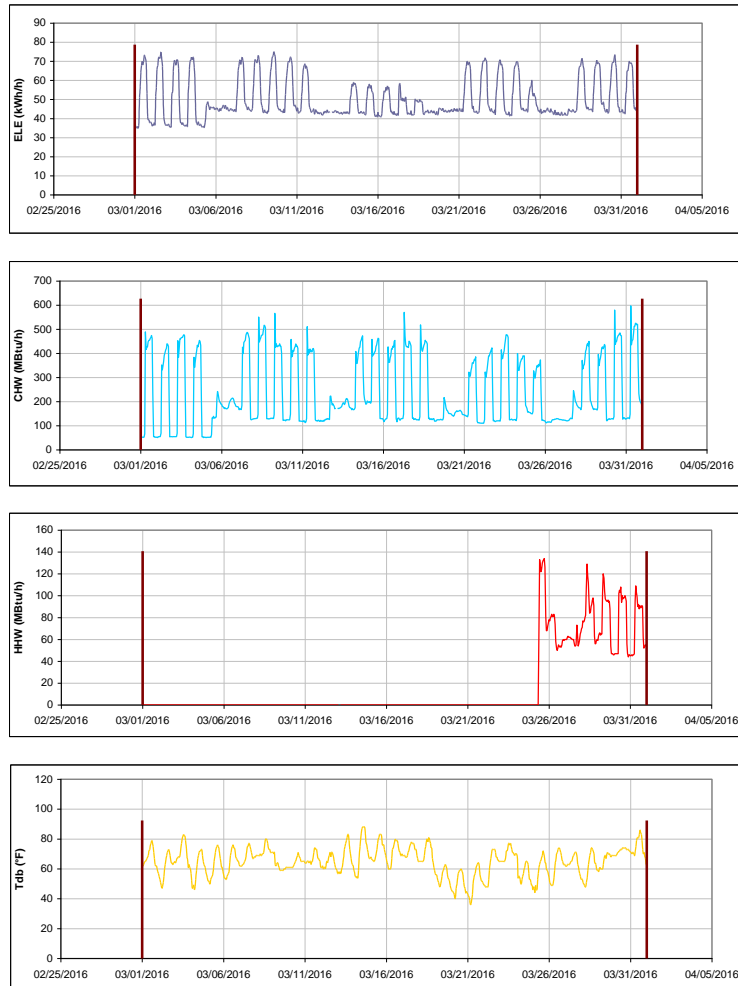
TAMU / BLDG #: 0480

Figure III-89 Hourly Whole Building Electricity, Chilled Water, and Hot Water Consumption for Bolton Hall during the Month of March 2016 and the Corresponding Hourly Outdoor Dry Bulb Temperature for College Station, TX

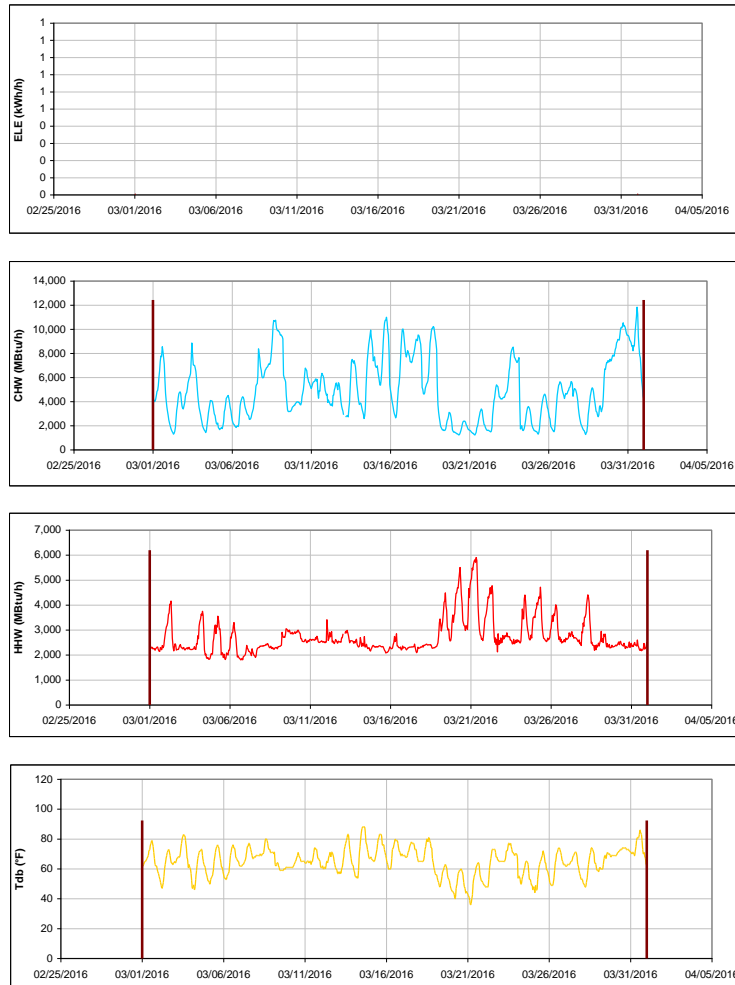
TAMU / BLDG #: 0484

Figure III-93 Hourly Whole Building Electricity, Chilled Water, and Hot Water Consumption for Chemistry Building during the Month of March 2016 and the Corresponding Hourly Outdoor Dry Bulb Temperature for College Station, TX

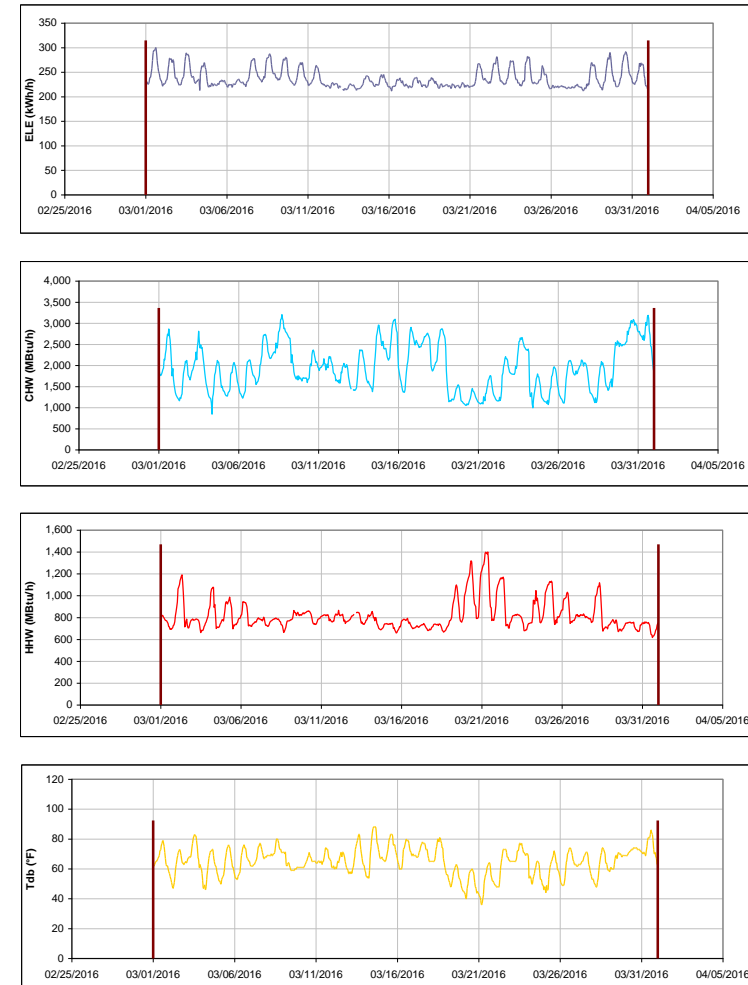
TAMU / BLDG #: 0490

Figure III-94 Hourly Whole Building Electricity, Chilled Water, and Hot Water Consumption for Halbouty Geosciences Building during the Month of March 2016 and the Corresponding Hourly Outdoor Dry Bulb Temperature for College Station, TX
